Navajo Abandoned Uranium Mine

Site Screen Report

Pete AUM Site

Navajo AUM Northern Region

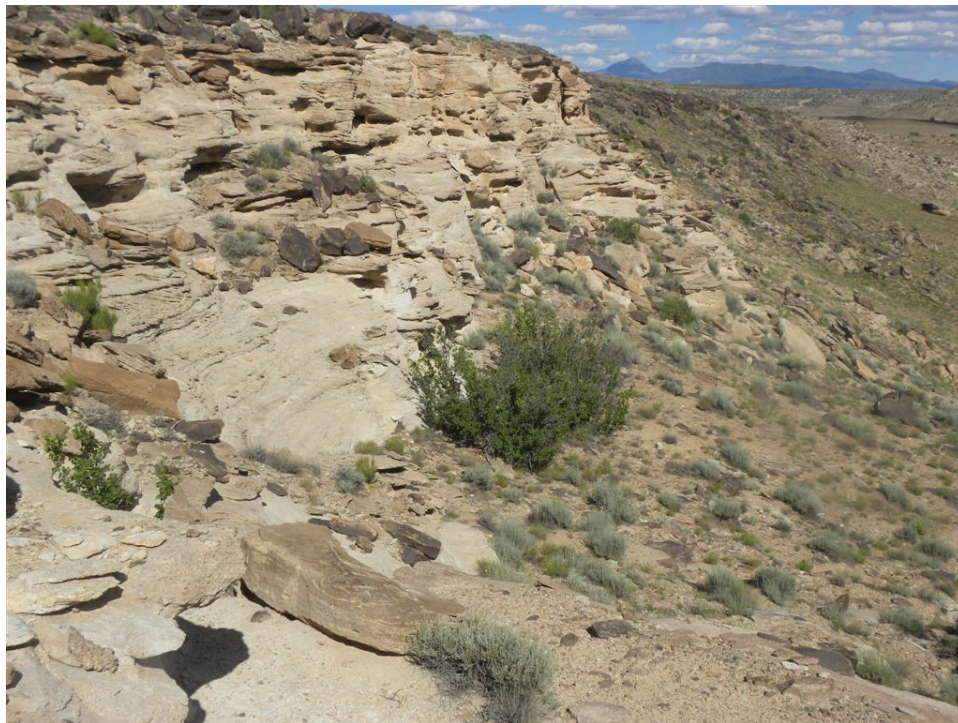
Photo 1. Pete site

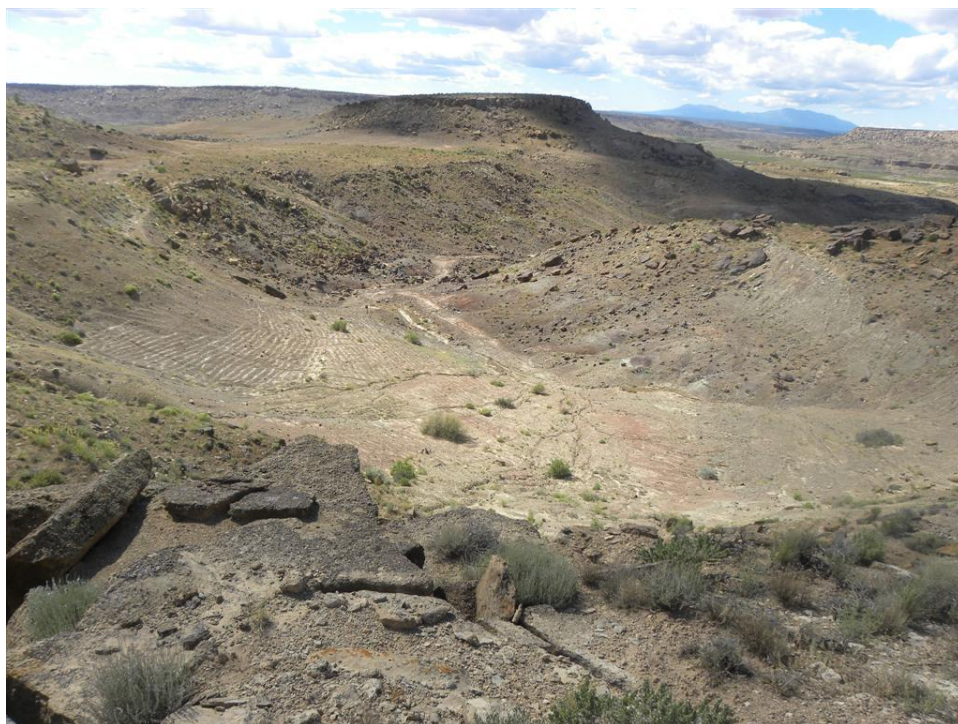
Photo 2. Pete site, NW gravel/dirt cap area

3 large gravel / dirt excavation / reclaimed areas sloping down site edges: NW cap 500'x500'; W cap 750'x750'; SE cap 750'x1000', majority of SE cap offsite

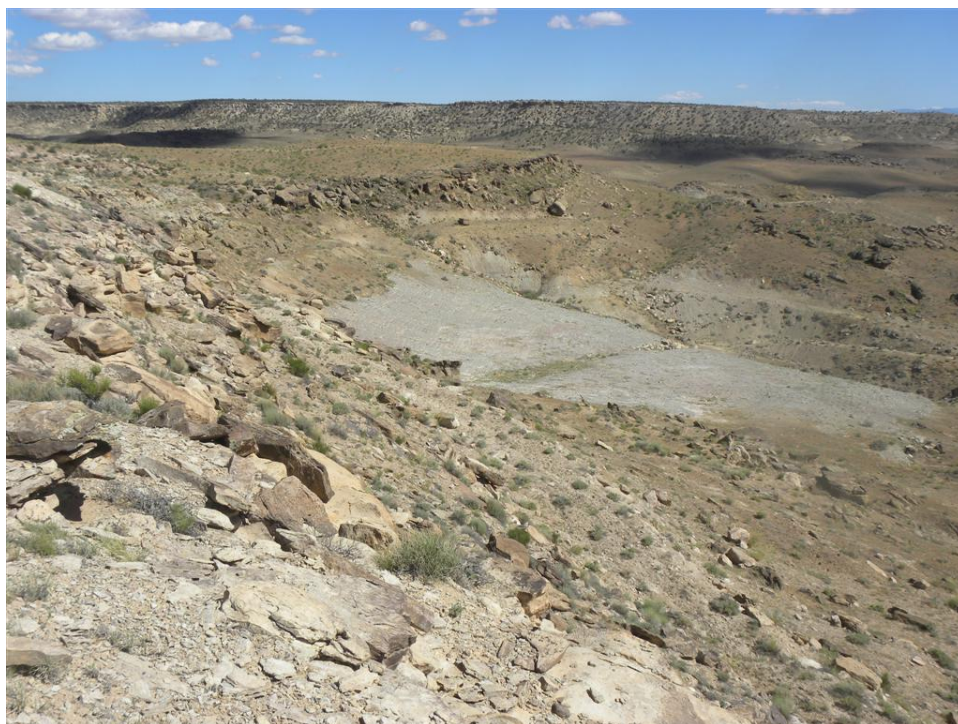
Photo 3. Pete site, W gravel/dirt cap area

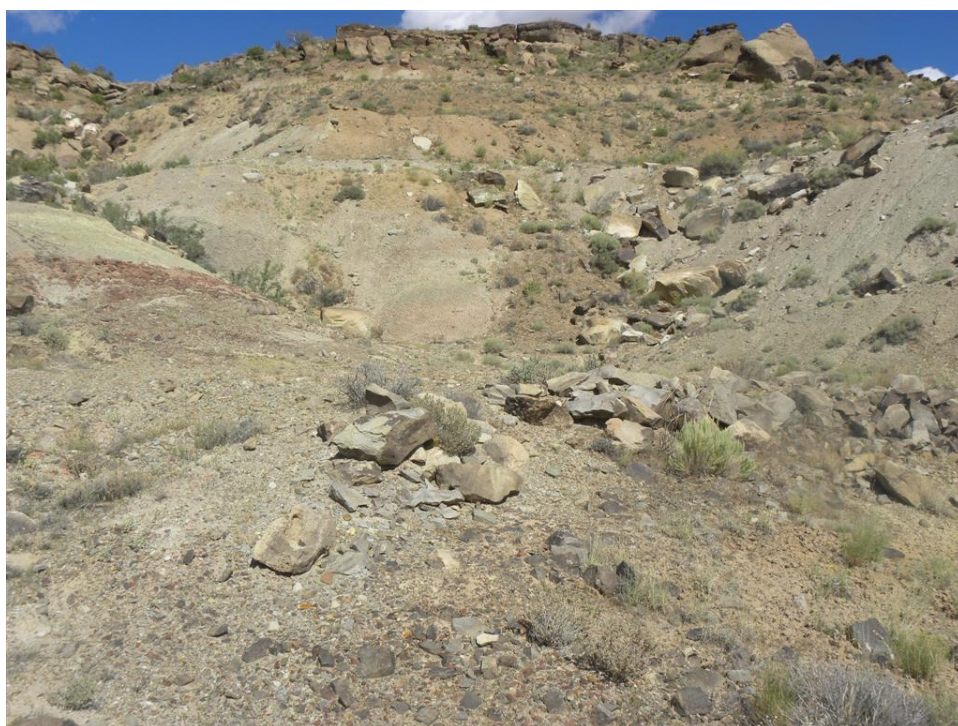
Photo 4. Pete site, W gravel/dirt cap area

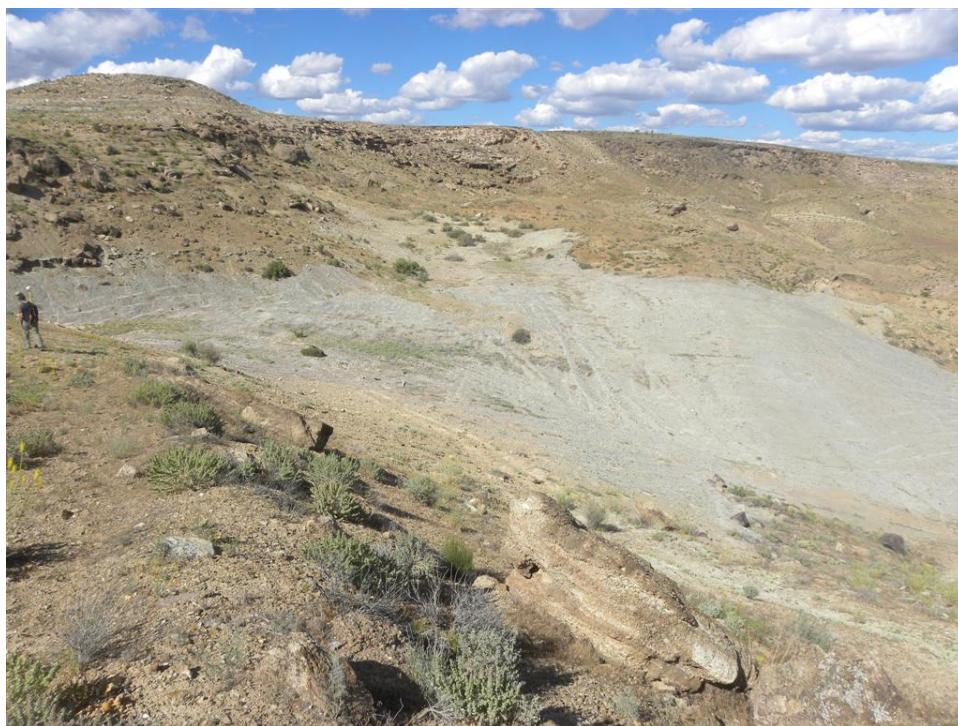
Photo 5. Pete site, SE gravel/dirt cap area
